Federal Reserve Bank Building
Seismic Study for Reuse Feasibility
March 5, 2014

FEDERAL RESERVE BUILDING
SEATTLE BRANCH

MARCH 5, 2014 FEASIBILITY

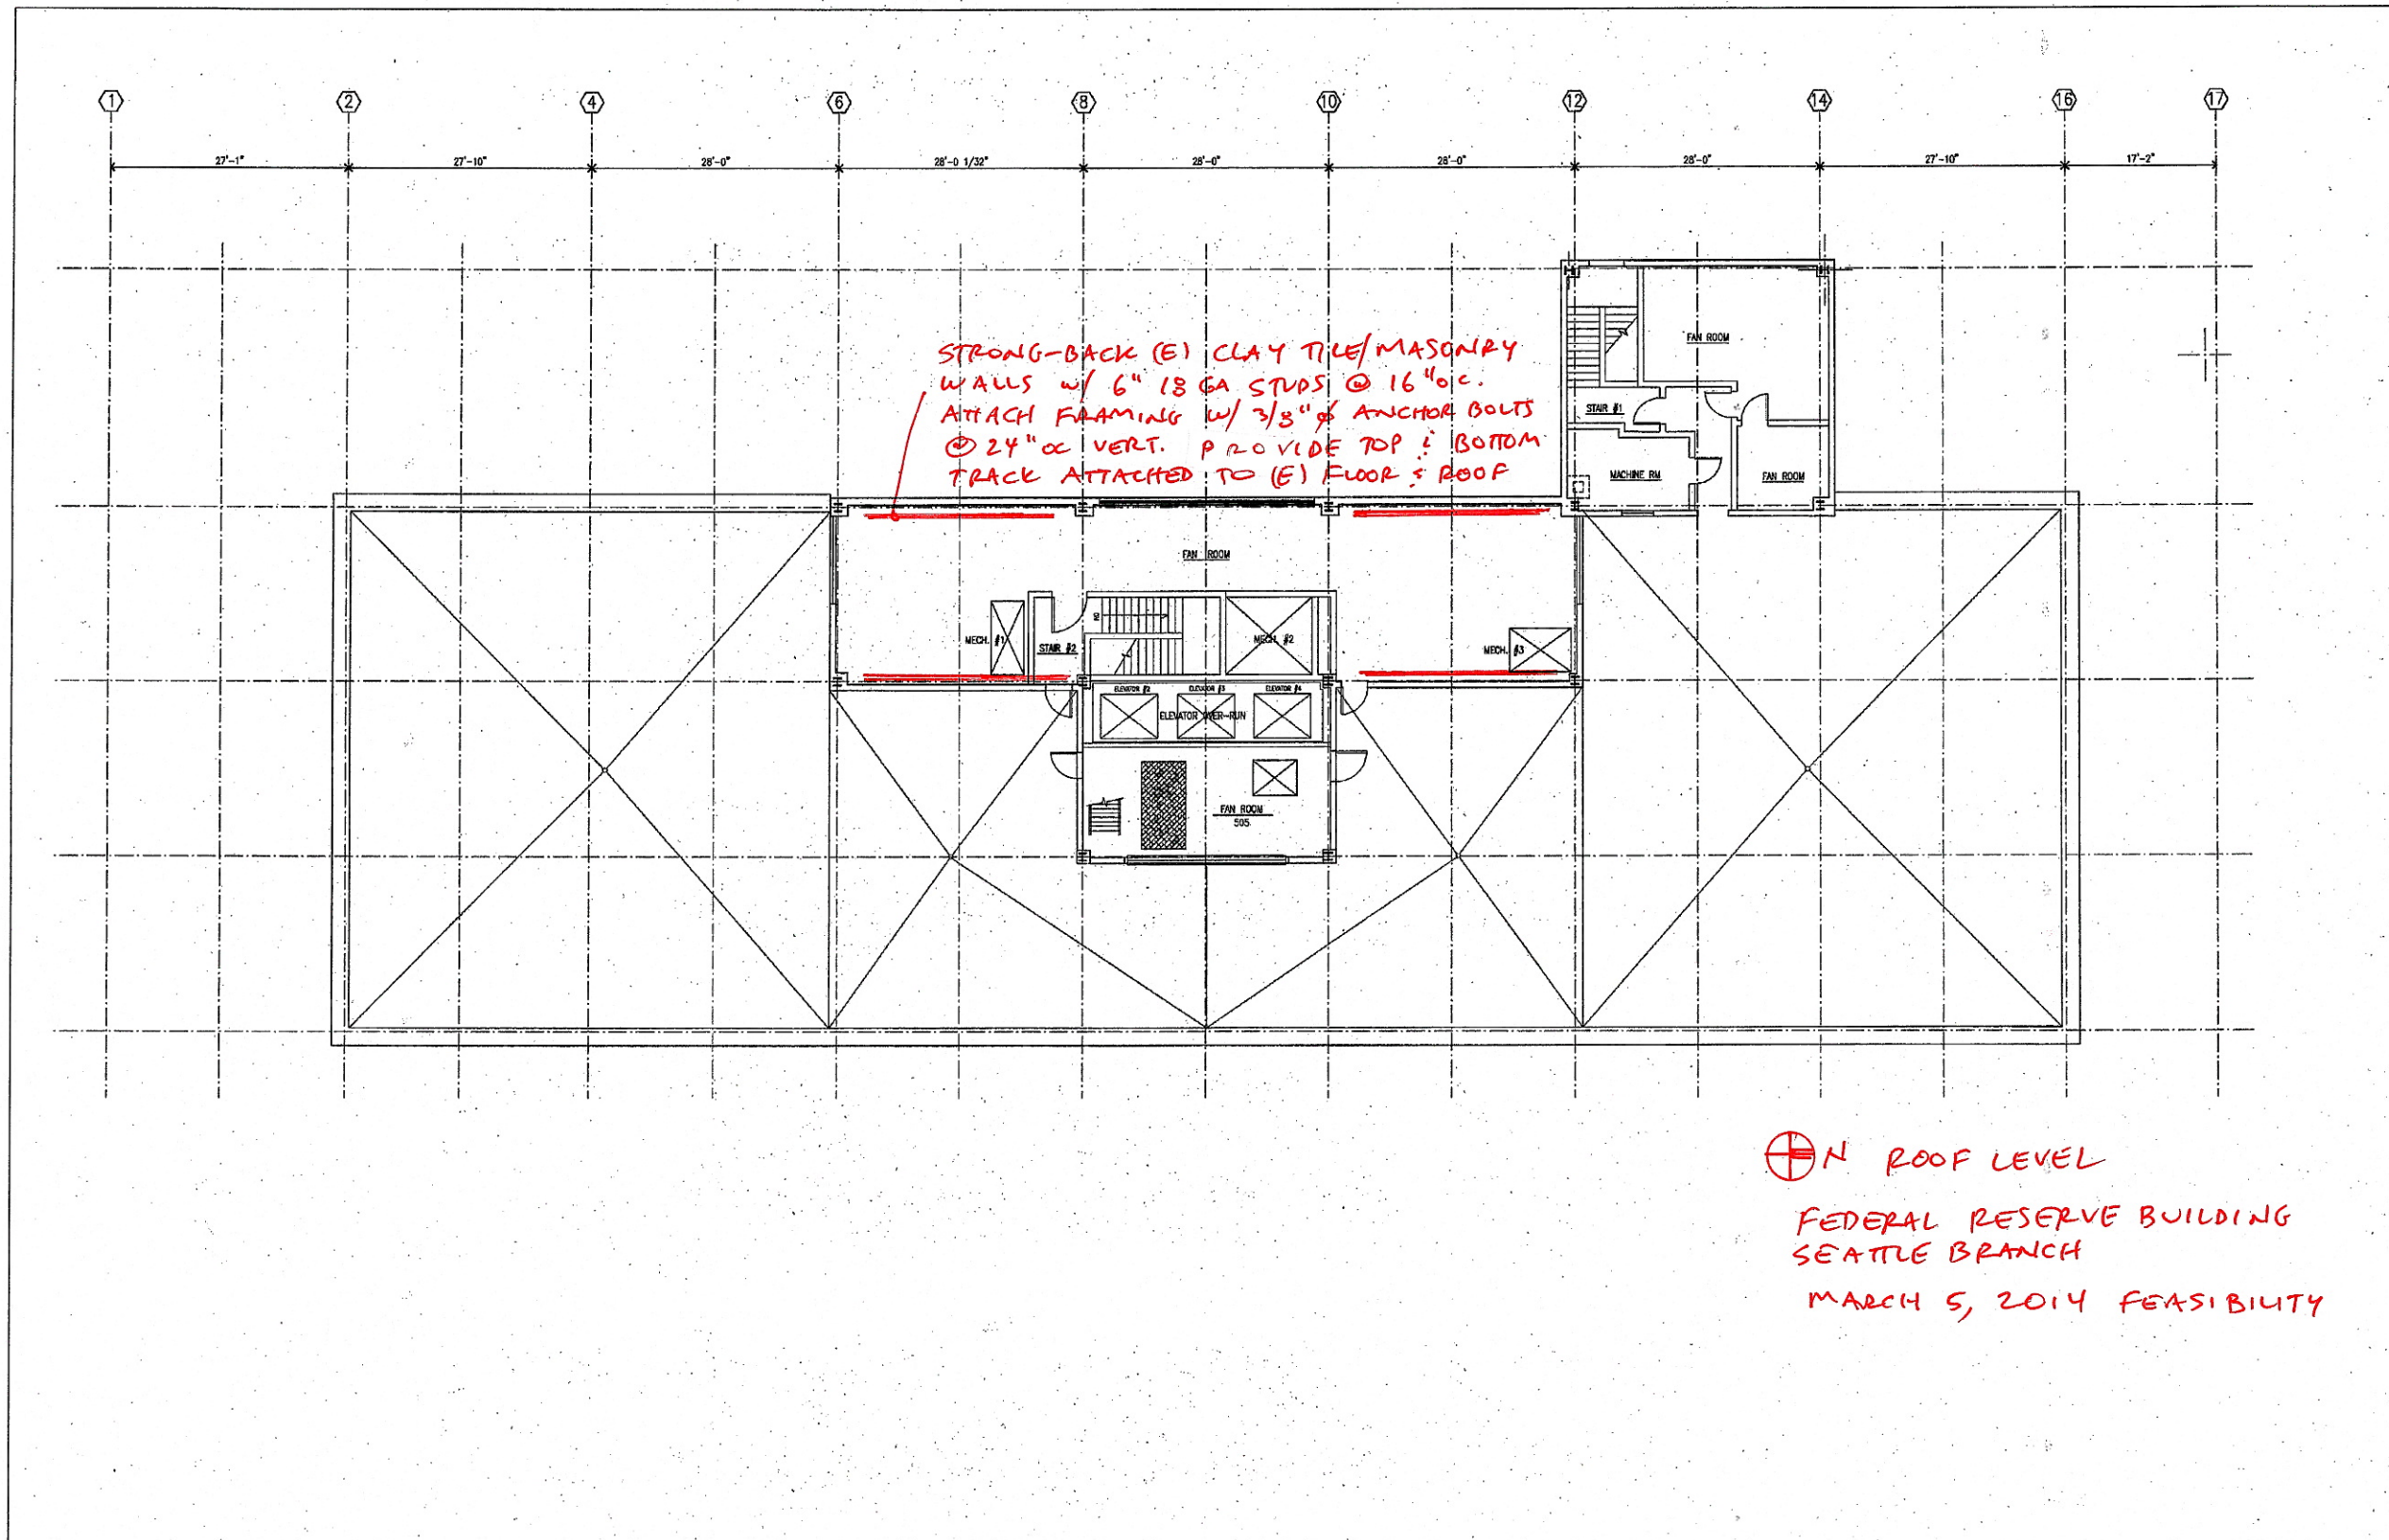
4TH FLOOR

We also found deficiencies in some non-structural components of the building including inadequate out-of-plane support for hollow clay tile and unreinforced masonry (URM) walls at the alley-side mechanical penthouse walls, interior partition walls and stair walls. Wall height-to-thickness ratios make them vulnerable to out-of-plane partial collapse under seismic loads. Partially collapsed walls could injure building occupants and block safe egress from the building.

- Provide steel strong-backing at clay tile and URM walls. Strong backing would consist of 6" 18 gauge steel studs and blocking attached to the face of the clay tile or masonry walls. Stud framing and blocking would be attached with 3/8" diameter drilled epoxy bolts or expansion anchors. Strong-back wall top and bottom tracks would also be attached to existing structure using epoxy bolts or expansion bolts.

VERIFY EXISTING WALL CONSTRUCTION
AT CORRIDORS, ELEVATOR LOBBY AND
OFFICE PARTITIONS.
PROVIDE STEEL STUD
STRONG BACKING OR
DEMOLISH AND REPLACE
WITH STEEL STUD WALLS
IF EXISTING WALLS ARE
HOLLOW CLAY TILE OR
UNREINFORCED MASONRY.
TYPICAL AT LEVELS 2 - 4.
